**Report of Procedures and Findings
From the Cleaning and Inspection of the**

**On Grade
City of Monroe
Monroe, OR**

**By
Midco Diving & Marine Services, Inc.**

June 25, 2018

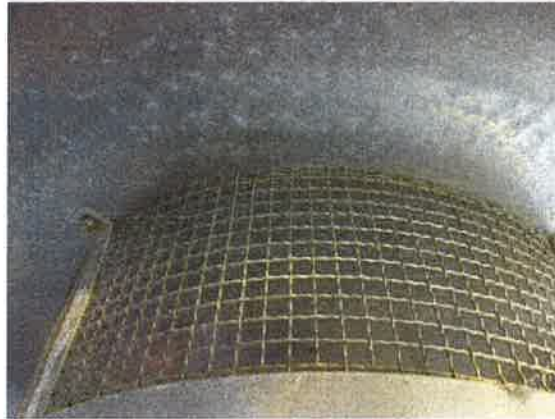
1. Roof vent screen is not #24 corrosion resistant mesh.

1. Install #24 corrosion resistant mesh on roof vent.
2. Replace sacrificial anodes.
3. Repair noted leak along seam joint at 9 o'clock position.
4. Have Midco Diving & Marine Services, Inc. clean and inspect every 2-3 years.

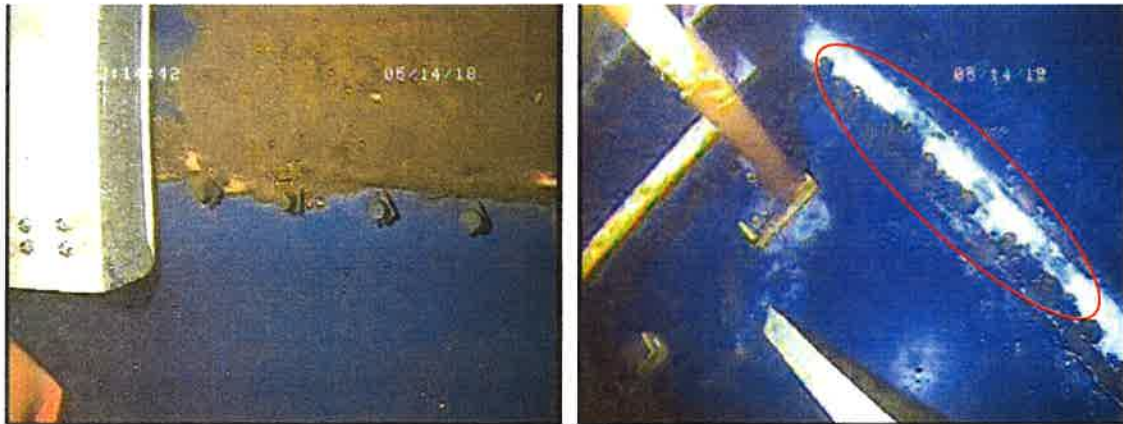
1. Up to 3 1/2" of sediment noted.
2. Sacrificial anodes noted at 0%.
3. Leak noted along seam bolt at 9 o'clock position.

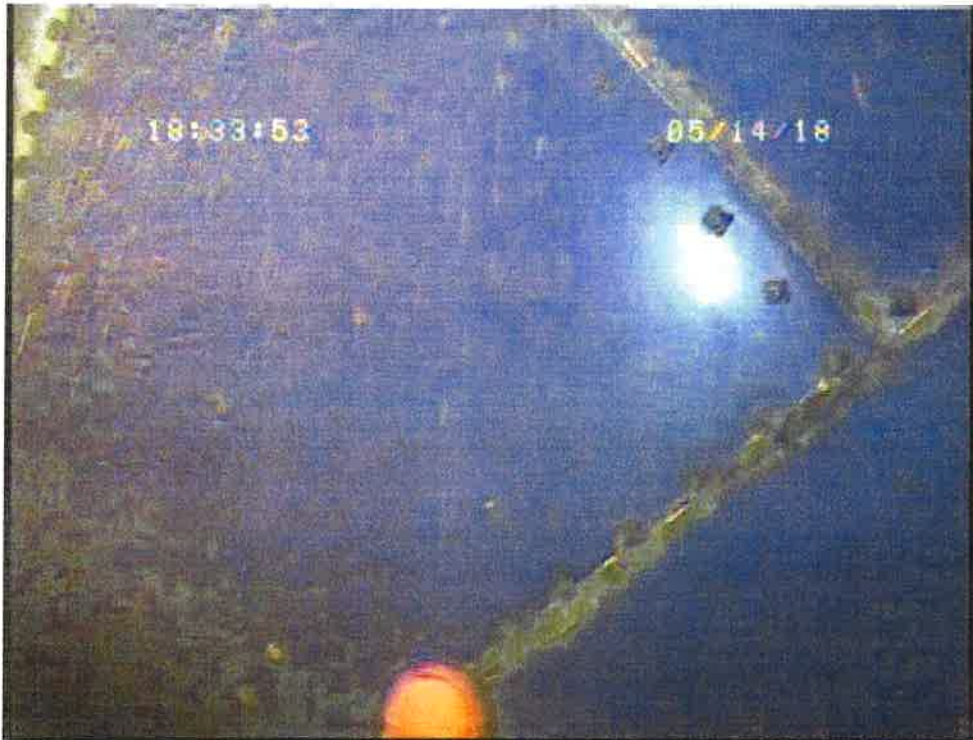
Typical Floor

Component	Condition					Comments
	NA	Ex.	Good	Fair	Poor	
<i>Interior Ladder</i>			X			Width: 22"
Caged	X					
Safety Climb	X					
<i>Telemetry Sensor</i>	X					
Functioning	X					
<i>Float</i>			X			Size: 17 1/2"
Guide Wires			X			
<i>Interior Floor</i>			X			
Coating			X			
Sediment			X			Depth: Up to 3 1/2" of sediment noted
Seams/Joints			X			
<i>Interior Walls</i>			X			
Coating			X			Staining noted
Seams/Joints			X			
<i>Interior Ceiling</i>			X			
Coating	X					
Rafters	X					
<i>Interior Man Entries</i>			X			Size: 24"
Coating	X					
Gasket			X			
<i>Support Columns</i>	X					
Coating	X					
Base	X					
Top	X					
<i>Cathodic Protection</i>			X			
Anodes	X					
Wires	X					
Sacrificial Anodes				X		% Left: 0

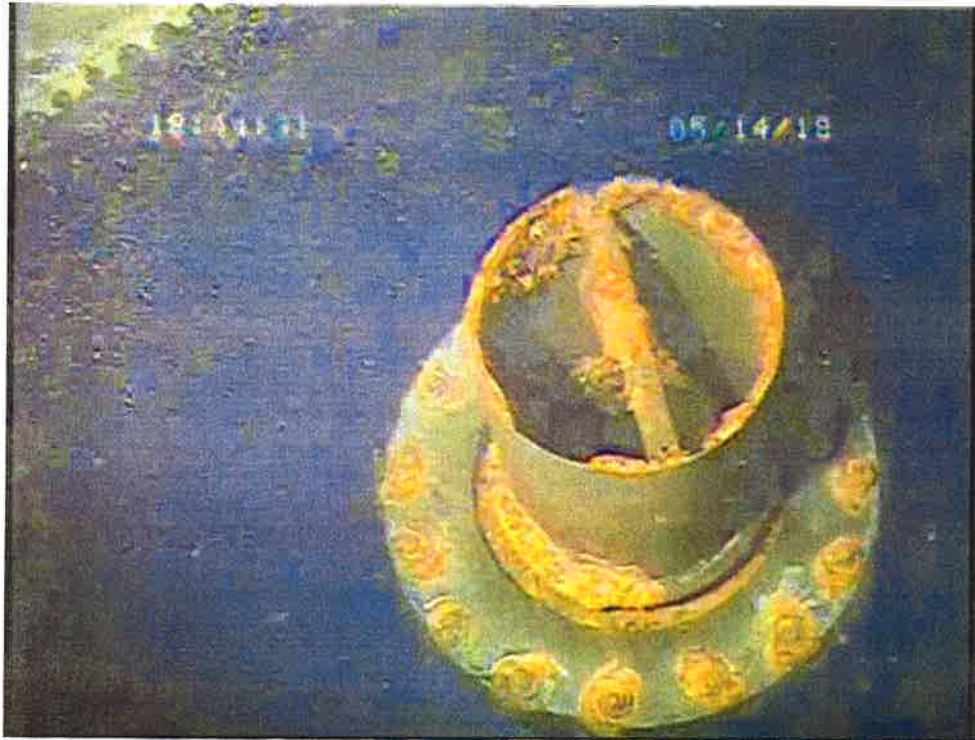
Outlet Plumbing

Component	Condition					Comments
	NA	Ex.	Good	Fair	Poor	
<i>Interior Overflow Pipe</i>			X			
Coating	X					
Top/Cap	X					
Connections/Flange	X					
<i>Interior Inlet</i>			X			Size: 10"
Coating	X					Corrosion noted
Riser			X			
<i>Interior Outlet</i>			X			Size: 9 3/4"
Coating	X					Corrosion noted
Riser			X			Measurement: 13 1/4"
<i>Interior Drain/Scour</i>	X					
Coating	X					
Riser	X					
<i>Interior Water Tap</i>	X					
Coating	X					
Valve	X
